What Causes The Cutter Notch on 5-N-1's To Round Out

Northern Tails Sharpening Inc Mobile, Alabama www.northerntails.com

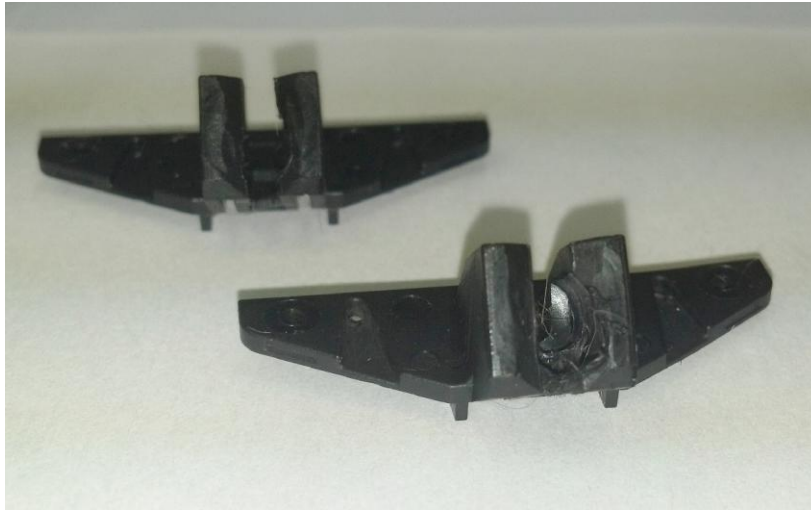
The cutter notch on your 5-N-1 is the means by which the cam (silver drive post) fits into, and the spinning cam moves your cutter blade back and forth. This cam can produce a lot of heat because its metal sliding in between two plastic posts. This notch needs lubrication or it can melt the plastic posts.

Lubrication can go away from the notch a couple of ways. Not re-lubing on a regular basis, cleaning the lubrication out by washing it out, or by simply running it out. When the lubrication is gone from the cutter notch, the cam will get hot and melt a round hole, and your blade will not cut anymore. When this happens, a new cutter notch has to be installed.

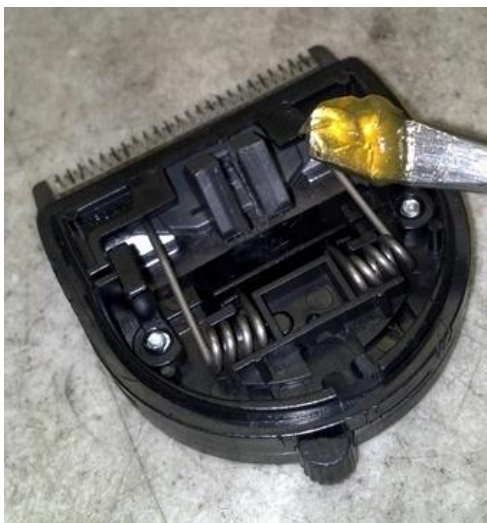
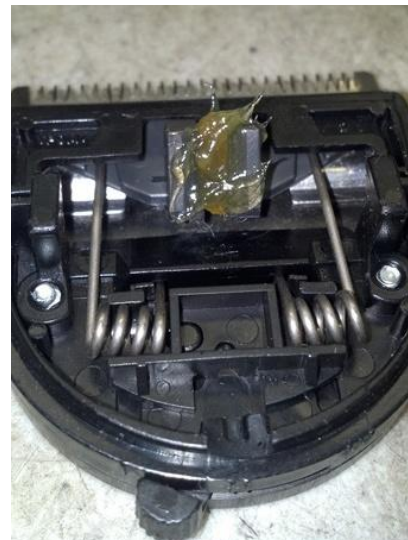
Its easy to lubricate from time to time. You can use an assortment of greases, and in a pinch Vaseline works as well. Be low are pictures of a properly lubricated cutter notch, you don't need to put as much grease in the notch as the picture shows (for demonstration purposes) but some grease in the notch will work for a long time as long as you don't clean it out somehow. You could have the same problems in the future if the cutter notch is allowed to go completely dry.
