QUICK FIX FOR THE NEW STYLE ANDIS BLADE DRIVE

A temporary fix you can do yourself with the new Andis blade drive

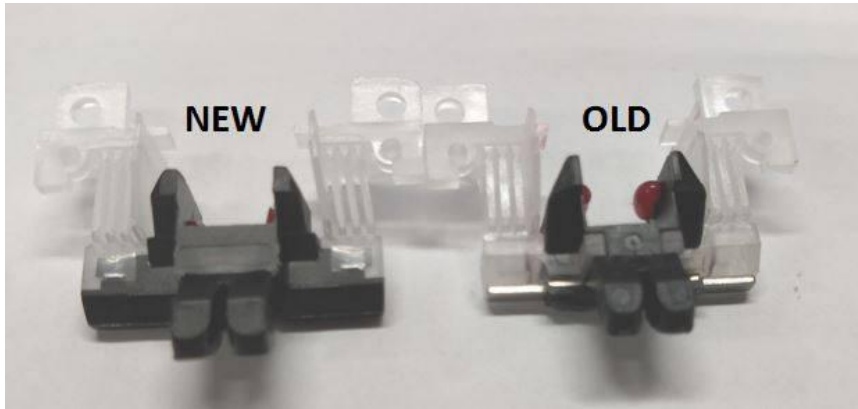
Here is the old blade drive compared to the new one. See how big the new one is? Because of its size it can hit the back of the hinge causing noise. You can fix this yourself.

The problem is the new drives are bigger because they took the metal strip off the front, and built up the black plastic to provide the stability that the metal bar did. This new drive leaves less space between the drive and the back of the hinge, then the old drive with the metal bar across the front. After some time of use the plastic becomes pliable and may start to bang against the hinge and make noise. All you need is your dremel, and grind a little off the front before installing it, you can do this yourself in 15 seconds. I painted the front part of the drive white that needs shaved off a bit. Just grind enough off where you think you took some off both sides the same. Only a small amount needs ground off (1/32nd of inch, very very little) If your hinge is bent from being dropped, you may never get rid of the noise unless you change the hinge. But try this first, because Andis is a great clipper, and this fix could make you and your clipper a happy couple again.

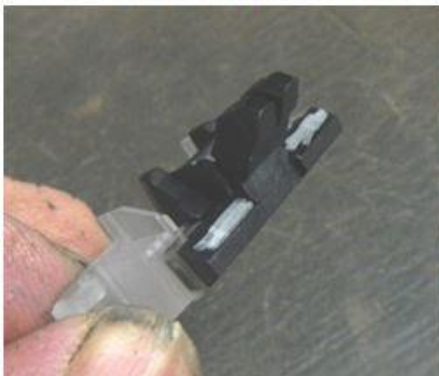
The larger blade drive can rub against the hinge and make noise. I've painted the part of the drive that moves real close to the hinge
